Update on NETAC's Compressor Pilot Project

Presentation to the NETAC
Technical Committee

October 30, 2007

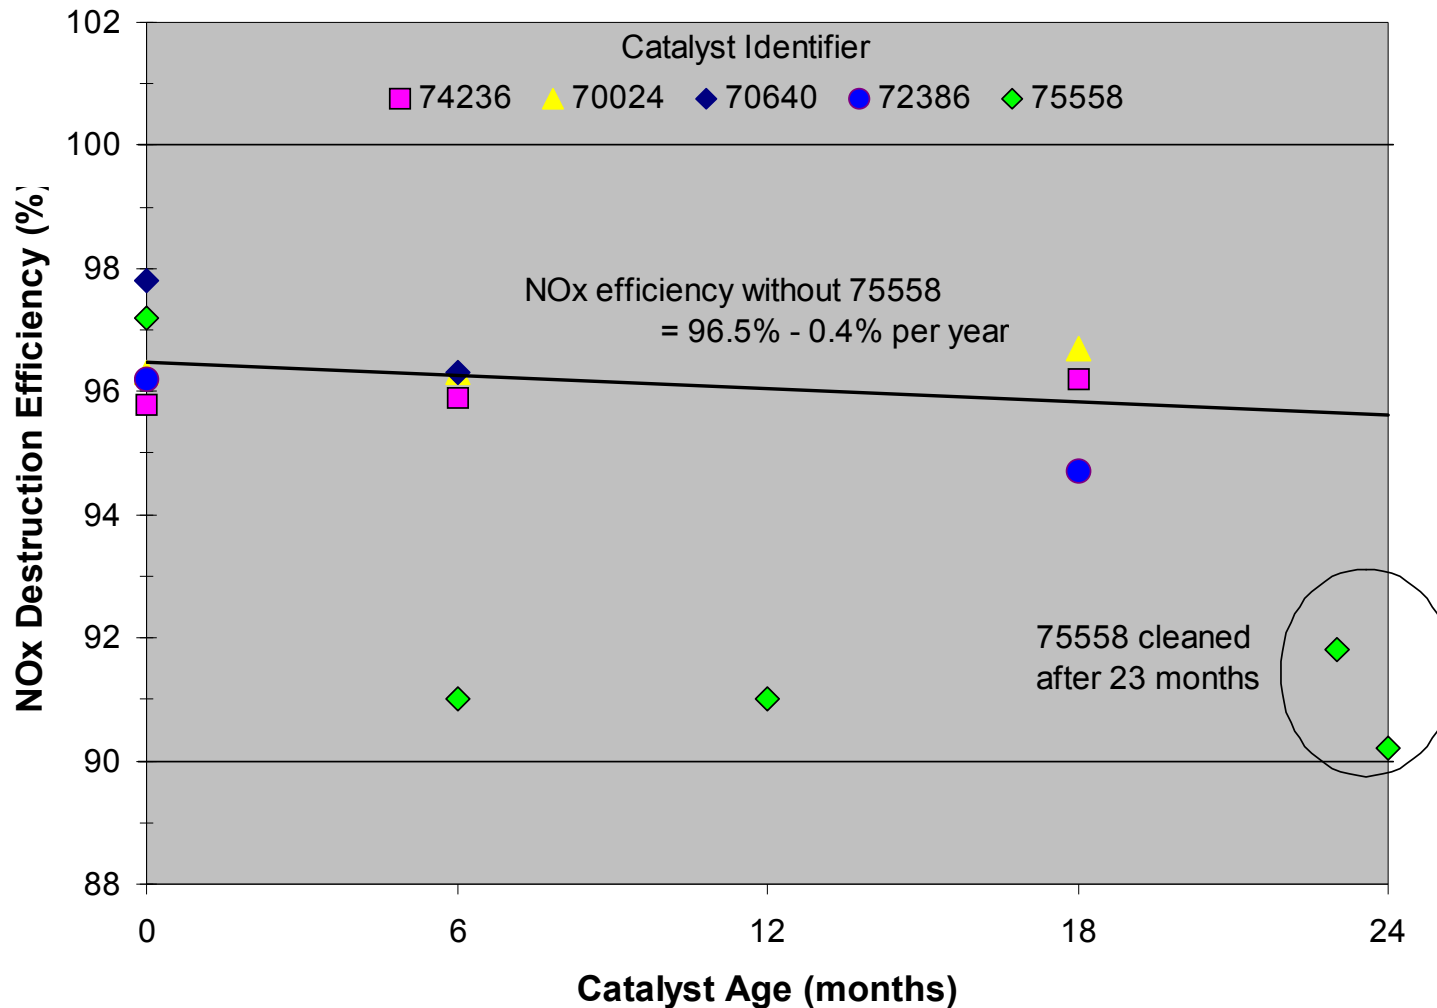
Catalyst Performance Over Two Years

- Longevity testing of catalysts installed on Exterran compressors
 - 3 catalysts re-tested at 18-24 months
 - One catalyst cleaned and re-tested
- BP's Findlay Compressor Station
 - Catalyst found to be blown out
 - No further testing

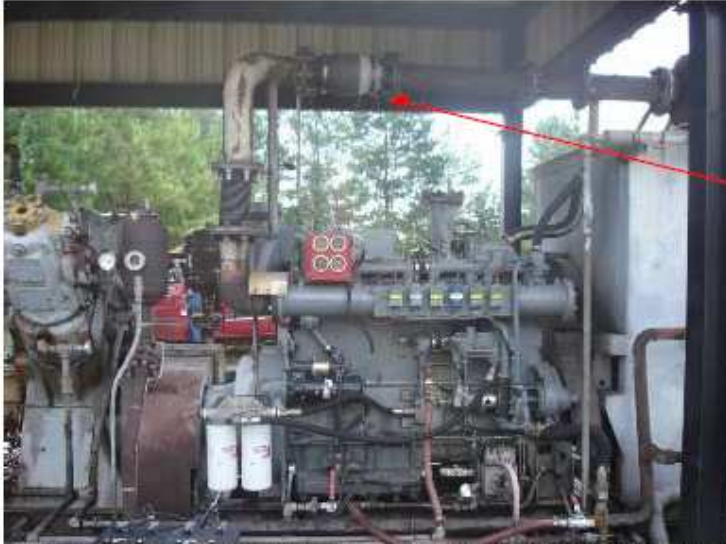
Figure 1. BP Findlay Compressor Station with Catalyst Installation.

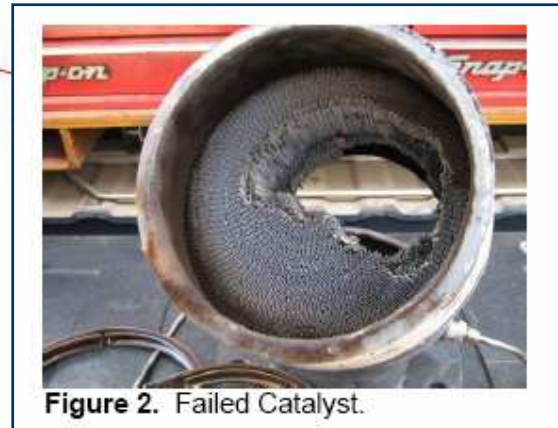
Blown Out Catalyst

Figure 2. Failed Catalyst.

Possible Causes:

Catalyst too hot

Air/fuel ratio problem or fouled plug?

Difficulty regulating engine at low load
